WO-A-0090

Tarakhil Thermal Power Plant – HDPE Fire Water Distribution
Piping Assessment Report

April 2, 2013

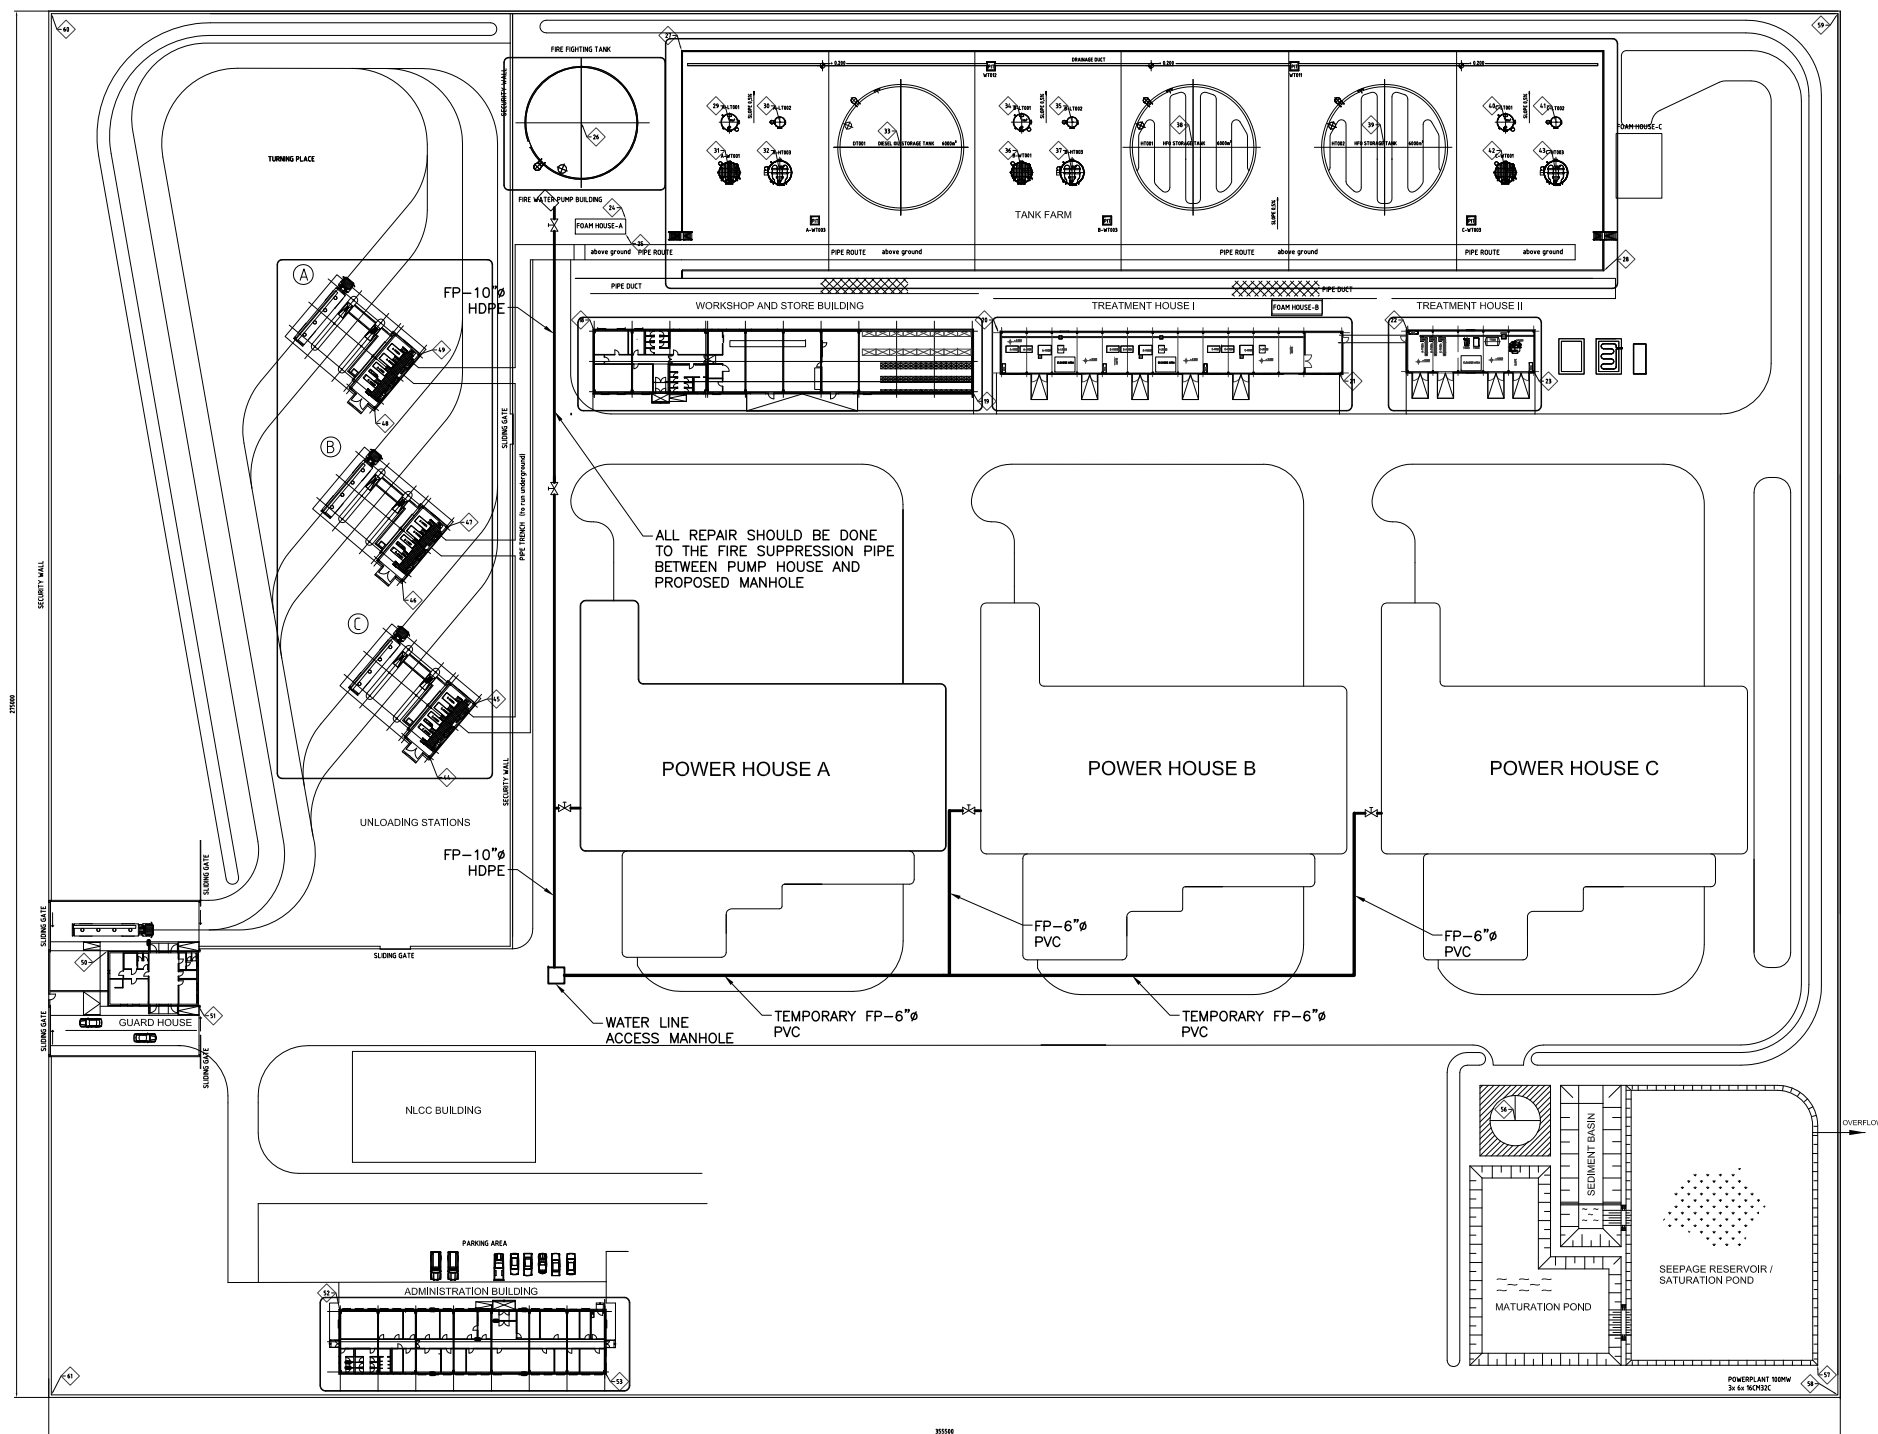
Appendix 4 Short Term Alternative 1

The recommended short term alternative is Short Term Alternative 1, Provide Temporary Fire Suppression Using the Existing Pump and New Temporary Lines. Short Term Alternative 1 would cost approximately \$28,000 and take approximately three weeks to complete.
